Inspection Report

Property Address:
123 Inspection Dr.
Shelby NC

J&P Home Inspections, LLC

Date: 10/18/2019	Time: 09:00 AM	Report ID:
Property: 123 Inspection Dr. Shelby NC	Customer: John Doe	Real Estate Professional:

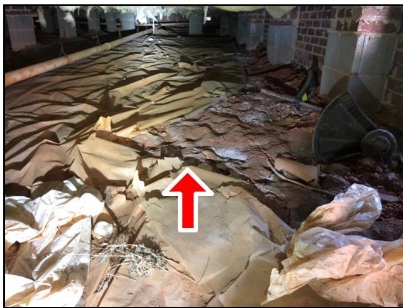
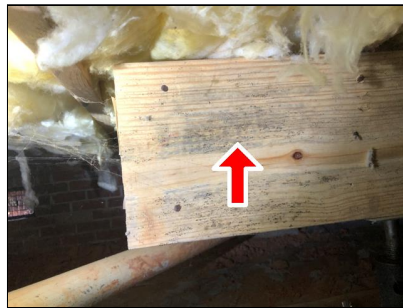
1.0 Foundations, Basement and Crawlspace

(1) **Deteriorated vapor barrier and some organic growth on the wood structure was noted throughout the crawlspace. Recommend further evaluation and repair as needed by a crawlspace specialist to prevent further elevated moisture levels which overtime can cause damage to the wood structure.**

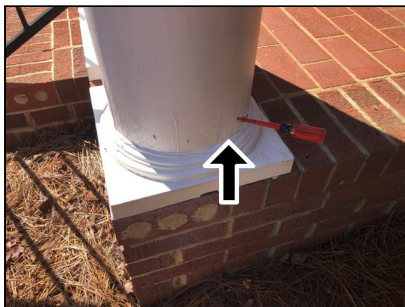
1.2 Columns - Piers

Some areas of soft wood were noted at the bottom of the outer front porch columns. Recommend keeping sealed to prevent further deterioration.

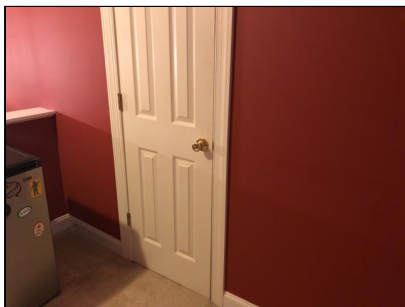
1.5 Roof Structure and Attic

Recommend installing childproof locks on all of the attic access doors. This is to prevent potential personal injury.

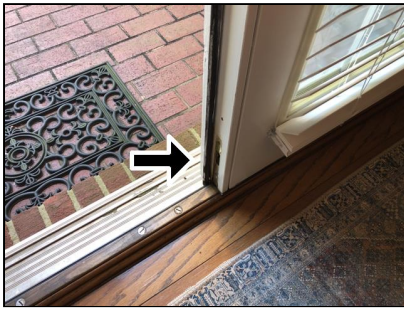
2.1 Doors (Exterior)

The rear french door needs repair to the latch to enable opening. Recommend repair.

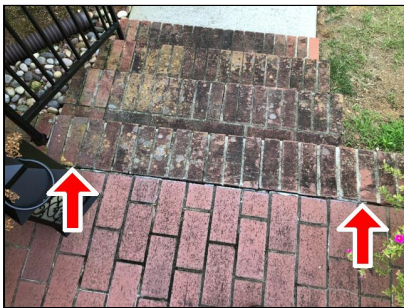
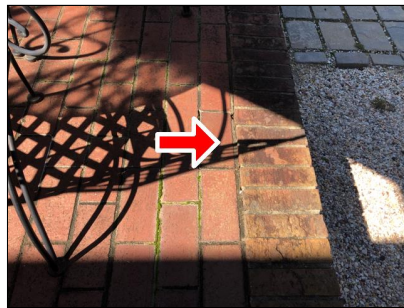
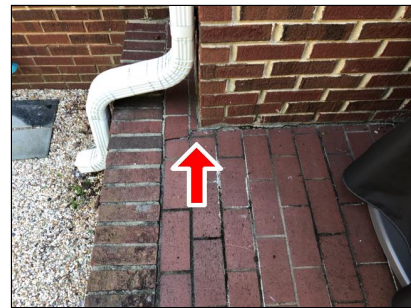
2.3 Porches, Decks, Steps, and Railings

(1) Mortar deterioration and some settlement was noted around the perimeter of the rear porch and steps. Recommend further evaluation and repair as needed by a masonry contractor.

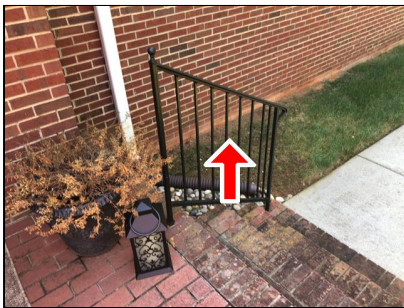
(2) Loose railing was noted at the rear porch. Recommend securing.

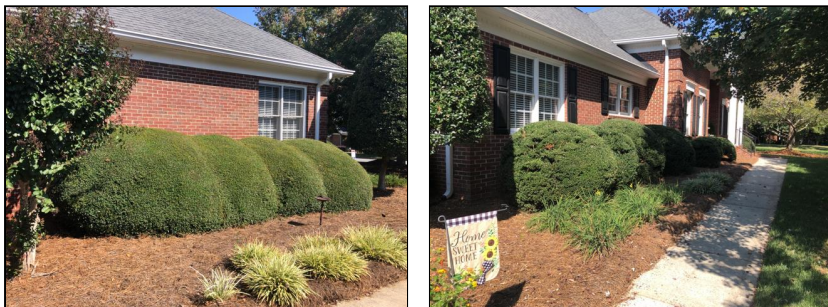
2.4 Vegetation, Grading, and Drainage

All vegetation should be cut back from around the home. This can retain water and cause damage to building components. Vegetation limited visual inspection of some areas.

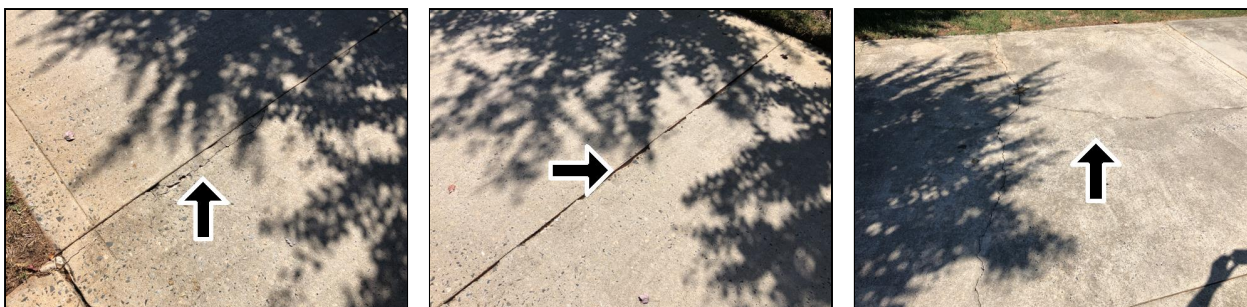
2.8 Driveways and Walkways

Some closed cracks and deterioration was noted in the driveway. Recommend repair as desired.

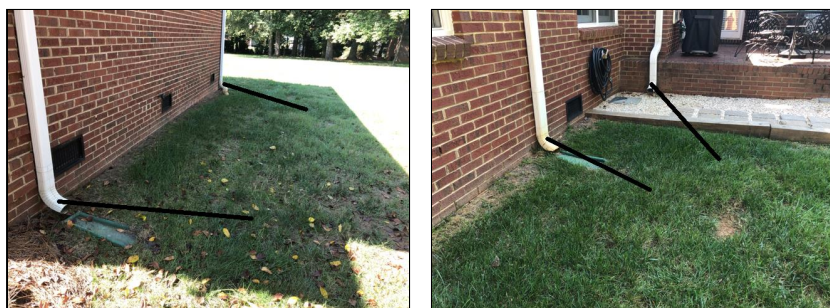
3.3 Gutters and Downspouts

Recommend installing extensions at all applicable downspouts around the home. This is to direct water away from the home's foundation.

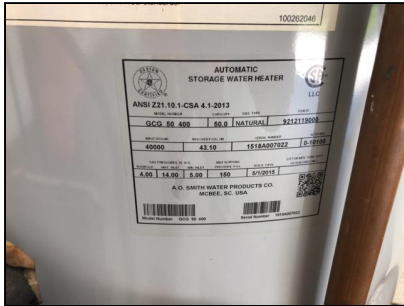
4.2 Hot Water Heater, Controls, Flues and Vents

- (1) Hot water temperature was above normal range. Recommend adjustment to prevent scalding.
- (2) Water heater label.

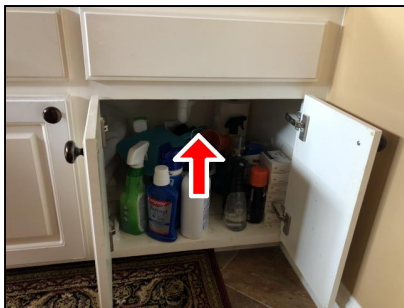
4.3 Fixtures (Sinks, Tubs, Showers, etc.)

- (1) An active leak was noted underneath a first floor left rear bathroom sink. Recommend repair to prevent further leaking and damage to surrounding building components.

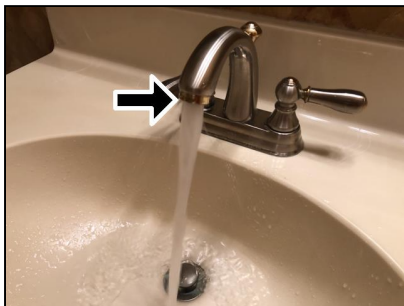
- (2) The sink faucet in the second floor bathroom sprayed erratically. Recommend repair as needed.

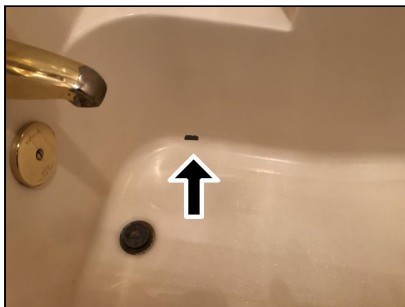
(3) A patched area was noted in the first floor right rear bathroom tub. Recommend monitoring as this area may be susceptible to leaks over time.

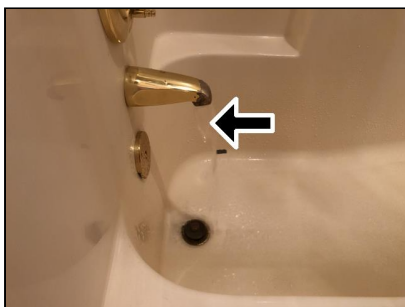
(4) Diverter valve in the first floor right rear bathroom did not seal completely while operating the shower head. Recommend repair.

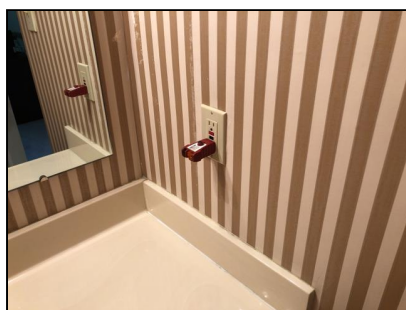
5.3 Operation of GFCI (Ground Fault Circuit Interrupters)

The GFCI receptacle in the first floor right rear bathroom did not trip when tested. This is a safety concern that should be repaired.

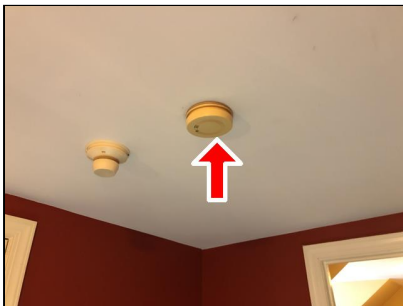
5.6 Smoke Detectors

There are not enough smoke/CO detectors installed in the home. Some of the units that are installed are discolored indicating that they are out of date. Recommend installing new units throughout the home.

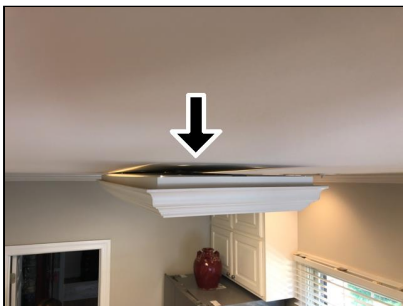
(2) A loose light fixture was noted in the kitchen. Recommend securing.

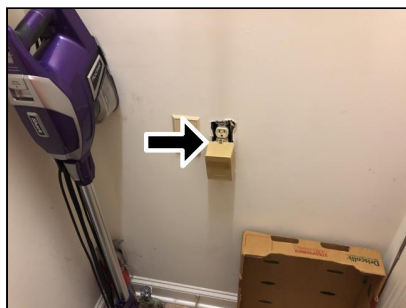
(3) A cover plate is missing in the kitchen pantry closet. Recommend repair.

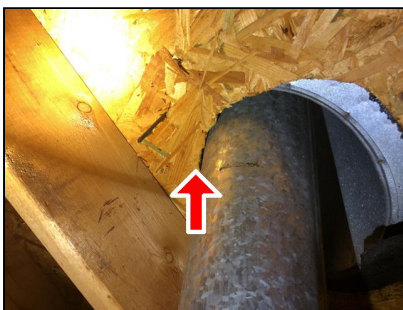
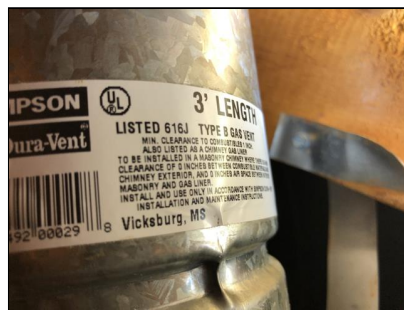
6.8 Chimneys, Flues and Vents (for fireplaces, heat systems)

(1) There is not enough clearance between combustibles and the gas furnace flue in the attic. Recommend repair as needed to prevent a potential fire hazard.

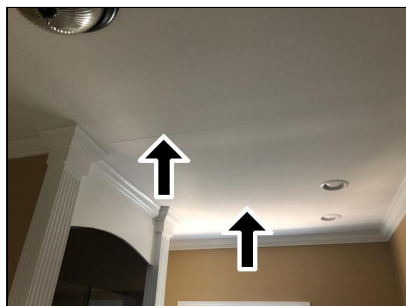
7.0 Ceilings

Closed cracks were noted in the ceiling of the first floor left rear bathroom. There was no displacement at time of inspection. Recommend repair as needed.

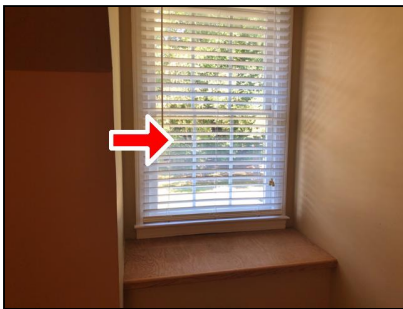
7.6 Windows (Representative Number)

(1) Most of the windows throughout the home would not open with reasonable force. This is likely due to not being operated in awhile and/or being painted shut. Recommend repair for egress purposes.

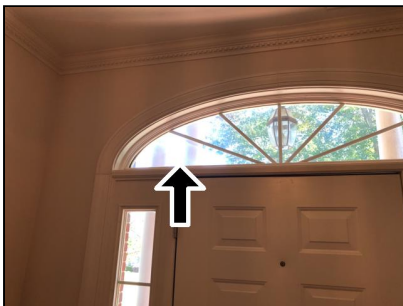
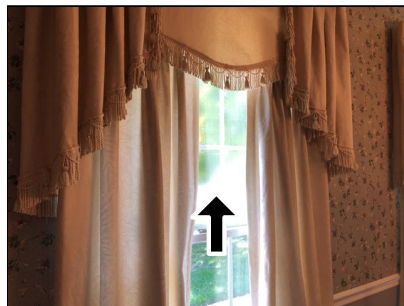
(2) Evidence of water intrusion was noted in between the panes of windows in the first floor middle front room and at the front entryway. This indicates a blown seal. Recommend repair.

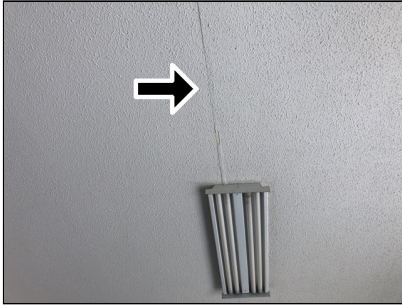
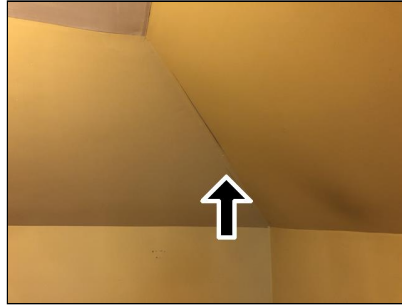
10.0 Garage Ceilings

Loose tape seams were noted in the ceiling of the garage and second floor middle room. Recommend repair as desired.

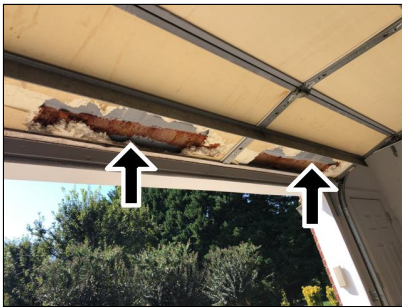
10.3 Garage Door (s)

Deterioration was noted in the foam insulation at the bottom of the garage door. Recommend repair as desired.

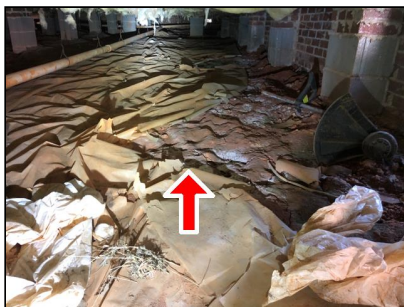
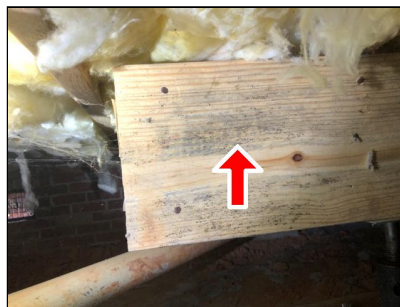
1.0 Foundations, Basement and Crawlspace

(1) **Deteriorated vapor barrier and some organic growth on the wood structure was noted throughout the crawlspace. Recommend further evaluation and repair as needed by a crawlspace specialist to prevent further elevated moisture levels which overtime can cause damage to the wood structure.**

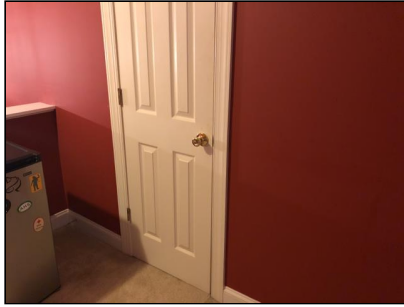
1.5 Roof Structure and Attic

Recommend installing childproof locks on all of the attic access doors. This is to prevent potential personal injury.

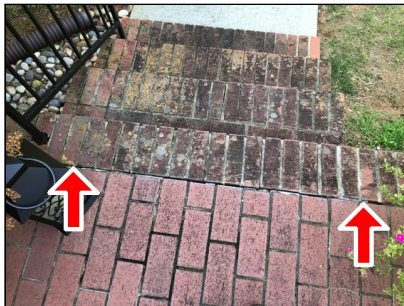
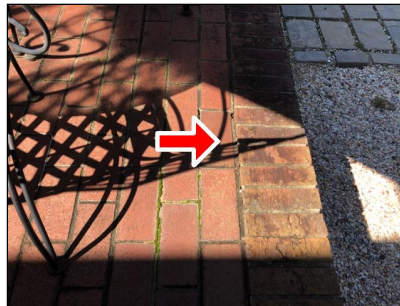
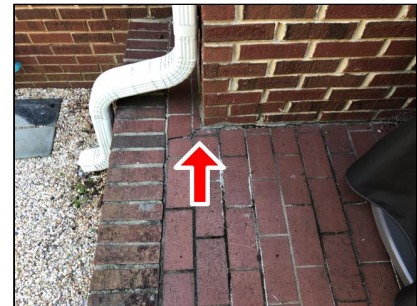
2.3 Porches, Decks, Steps, and Railings

(1) Mortar deterioration and some settlement was noted around the perimeter of the rear porch and steps. Recommend further evaluation and repair as needed by a masonry contractor.

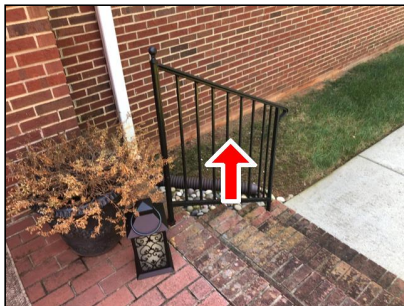
(2) Loose railing was noted at the rear porch. Recommend securing.

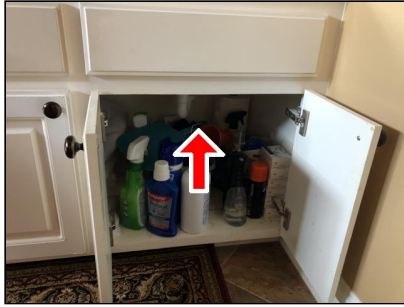
4.3 Fixtures (Sinks, Tubs, Showers, etc.)

(1) An active leak was noted underneath a first floor left rear bathroom sink. Recommend repair to prevent further leaking and damage to surrounding building components.

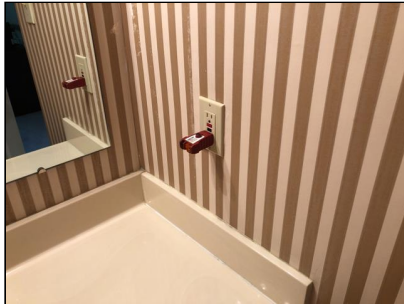
5.3 Operation of GFCI (Ground Fault Circuit Interrupters)

The GFCI receptacle in the first floor right rear bathroom did not trip when tested. This is a safety concern that should be repaired.

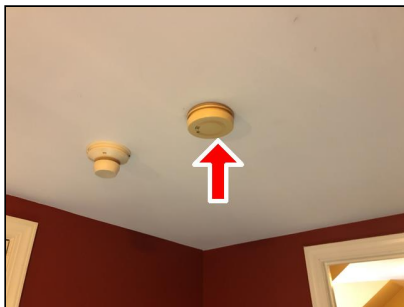
5.6 Smoke Detectors

There are not enough smoke/CO detectors installed in the home. Some of the units that are installed are discolored indicating that they are out of date. Recommend installing new units throughout the home.

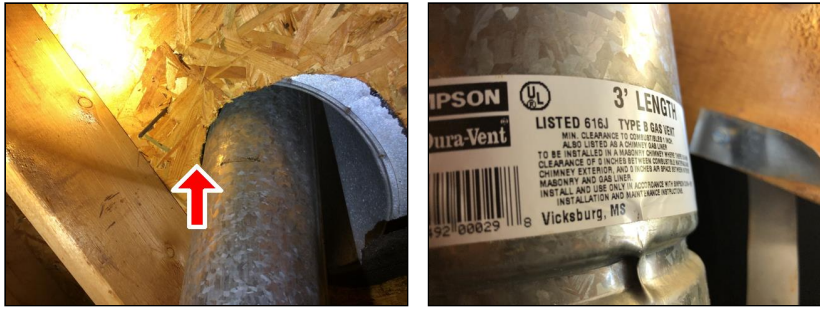
6.8 Chimneys, Flues and Vents (for fireplaces, heat systems)

(1) There is not enough clearance between combustibles and the gas furnace flue in the attic. Recommend repair as needed to prevent a potential fire hazard.

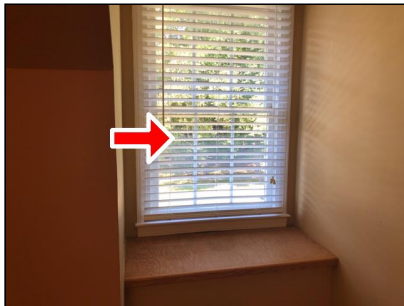
7.6 Windows (Representative Number)

(1) Most of the windows throughout the home would not open with reasonable force. This is likely due to not being operated in awhile and/or being painted shut. Recommend repair for egress purposes.
